## Project History: Oil Contaminated Workshop Floor

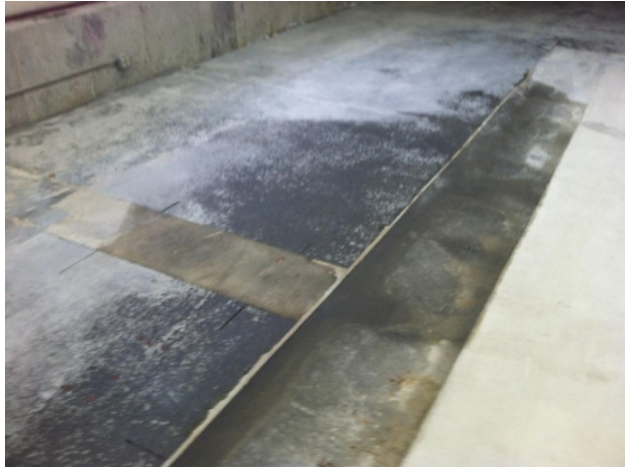
**Before:** Oil stained substrate used to store construction plant and equipment. Concrete subject to 20 yrs of oil contamination from motor and hydraulic oil.

Massachusetts Contractor had made several attempts to clean up oil contamination concrete in large workshop area. Workshop was used to store construction equipment and vehicles overnight and between projects. Oil contamination was estimated to be in excess of 20 years. Use of a citrus degreasers did clean the surface but oil bleed back would return typically 3 days after cleaning.

1st stage involved an initial deep clean. The floor area was saturated with water using a low pressure pressure washer. CoverClean HC was then applied neat at 200 sq.ft per gal and scrubbed in using deck brushes. The product was allowed to sit overnight and then rinsed and squeegeed to drains in the floor. 2nd stage the product was diluted 1 part cleaner to 2 parts clean water and the diluted CoverClean HC sprayed again on the surface. This application was allow to penetrated into the surface

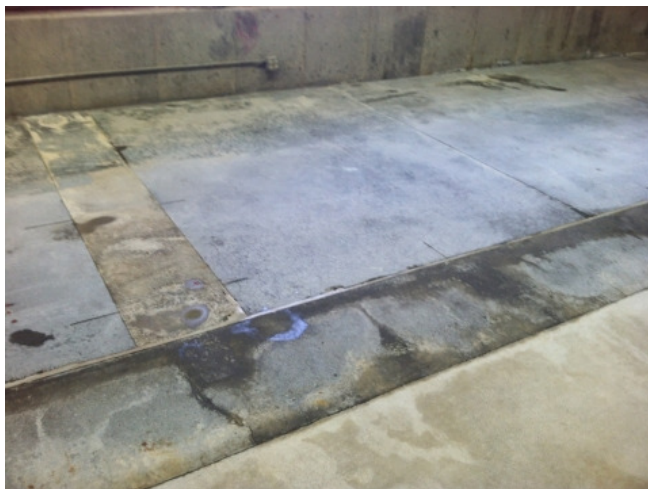
**After:** 1 week after surface was cleaned CoverClean HC. No sign of oil “bleed back” Two applications of CoverClean HC were necessary. One at full strength. The second at a 2:1 dilution.

After 1 week of letting Microbes dwell in concrete no sign of any oil bleed back was observed. Contractor was then in a position seal floor with epoxy coating to protect against further oil contamination
